## TRACK PROBLEMS AND CORRECT APPLICATION

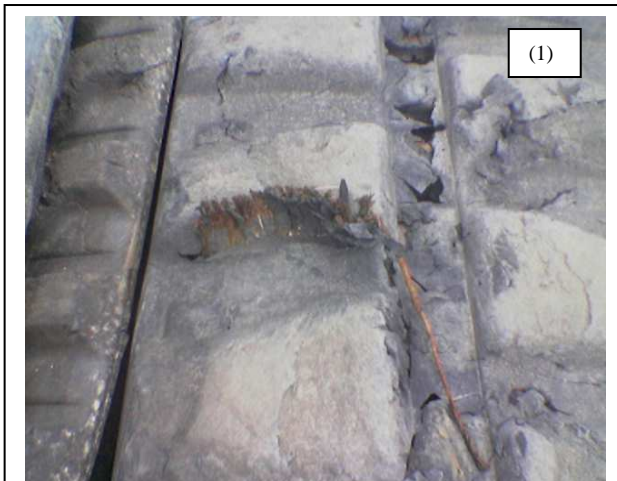
### TENSION CORD FRACTURE –

Caused by recoil tension being with overload to track. Track recoil is beyond shear rating of track. This can be caused by over tension of track or insufficient recoil travel to forgive. More common in after market or overlap join type tracks.

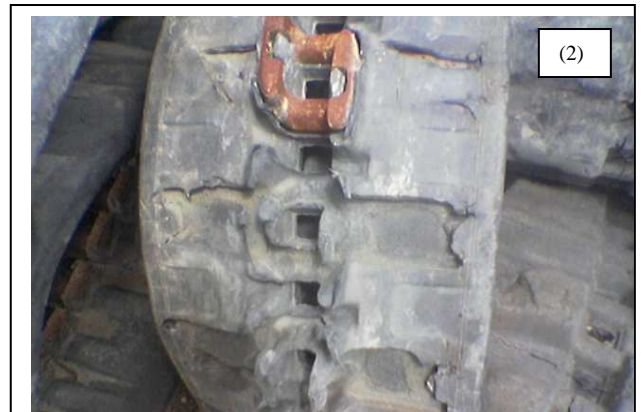
**RAIL DISLODGE**MENT- can be caused by over tension, or incorrect rail offset type being used. Common in Kubota , Yanmar & Komatsu where operator has fitted incorrect offset or rail height. Usually the machine is with rough ride prior to failure caused by roller dropping into rail gaps. Also caused by high speed direction change when blading.

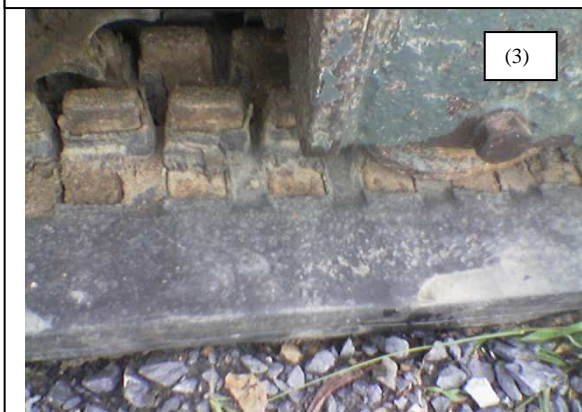
### YANMAR – KUBOTA – 3 & KOMATSU MACHINES

Note that track is with roller flange running into rubber and causing link bond failure if steel geive is not raised. This causes the failure as depicted in picture (2) If outside running roller is used a raised geive rail is needed.

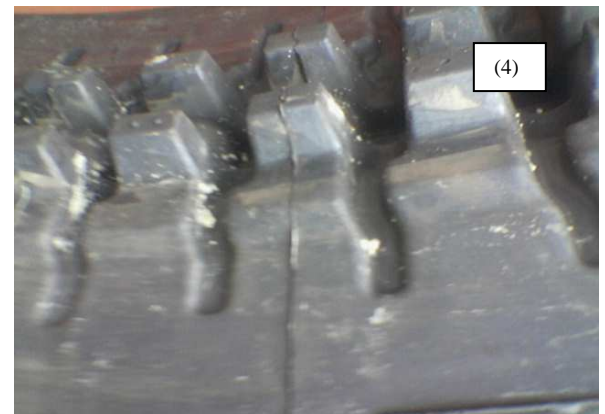
### CORRECT YANMAR – KUBOTA-3 & KOMATSU TRACK

Note raised geive rail for roller to run on. This track is only available from a hand full of suppliers and not included to interchangeable types. This is 400 72.5 Y – K – G types Komatsu is K , Kubota is G – Yanmar is Y. J” Type is to all types meaning continuous wound cord.

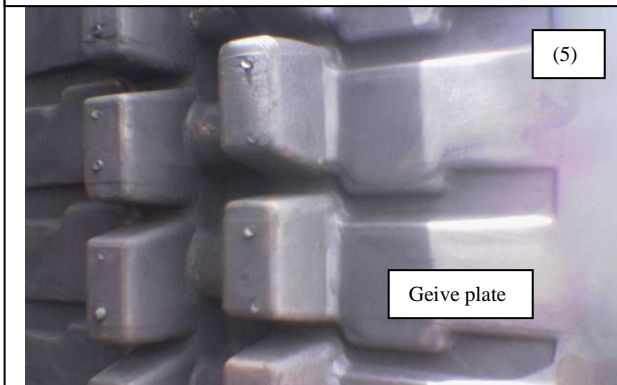
**NEW KUBOTA and KOMATSU RAIL** – Note rail offset and timing pass to raised geiving. 320 - 300 – 280 size This type of track is designed for roller flange to bare weight down on geive plate not on upper rail edge.

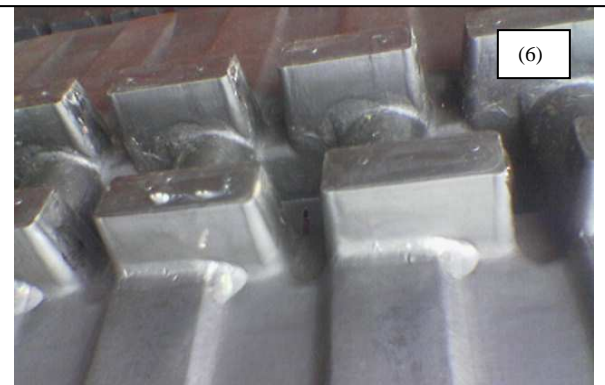
Standard 300 mm and 400 mm rail configuration. Note in (4) the larger Yanmar – Komatsu track has no rail offset and if that track is used on Kubota, Hitachi, Kobelco they will fail prematurely due to roller dropping into rail gaps forcing the rails apart and rail delamination as in (2). Insufficient rail offset also causes this type of failure. This type of track is designed for roller to run on top of rail .
